**POST CONSTRUCTION
STORMWATER MANAGEMENT REPORT
FOR
CHIQUES CROSSING**

RAPHO TOWNSHIP
LANCASTER COUNTY

PROJECT NO: 1212-002

(CONDITIONAL USE SUBMISSION)

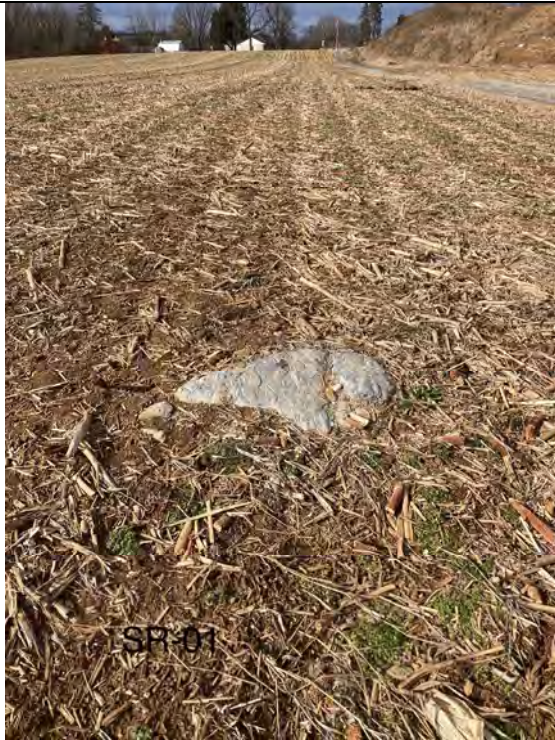
SR-01

Surficial Rock (SR-01)

ECS recommends these features be explored with a test pit at each location under the supervision of ECS in the early stages of earthwork in order to determine if potential repairs are necessary.

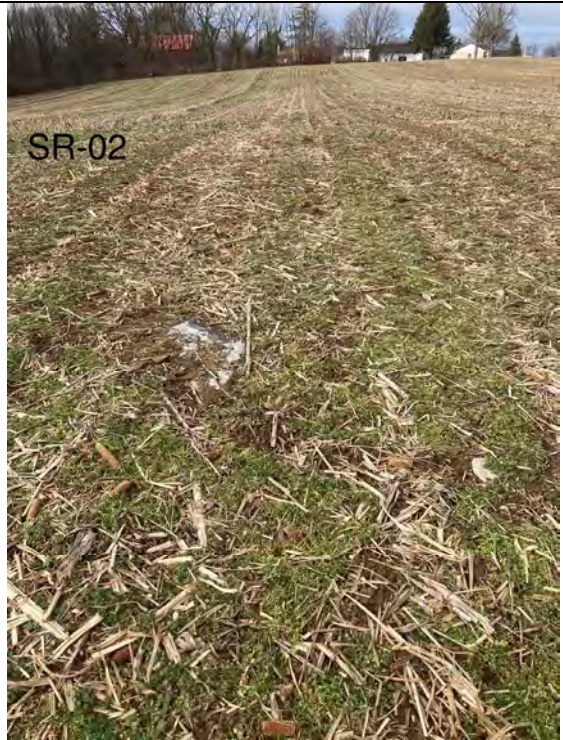
SR-02

Surficial Rock (SR-02)

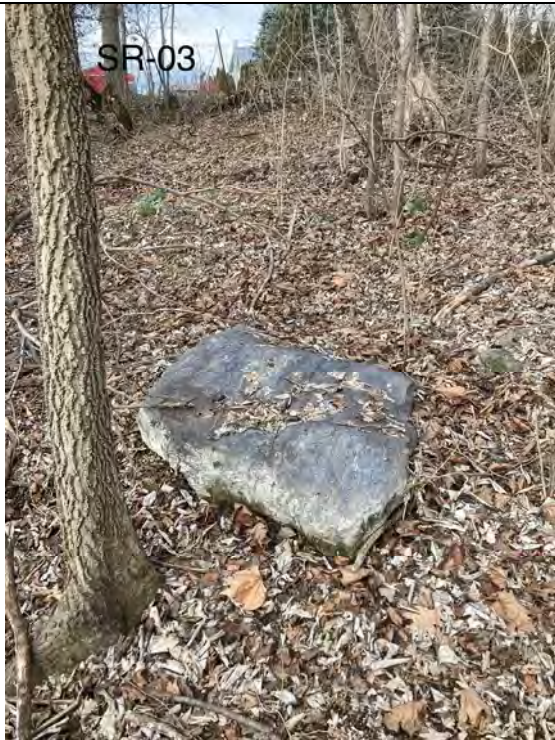
SR-03

Surficial Rock (SR-03)

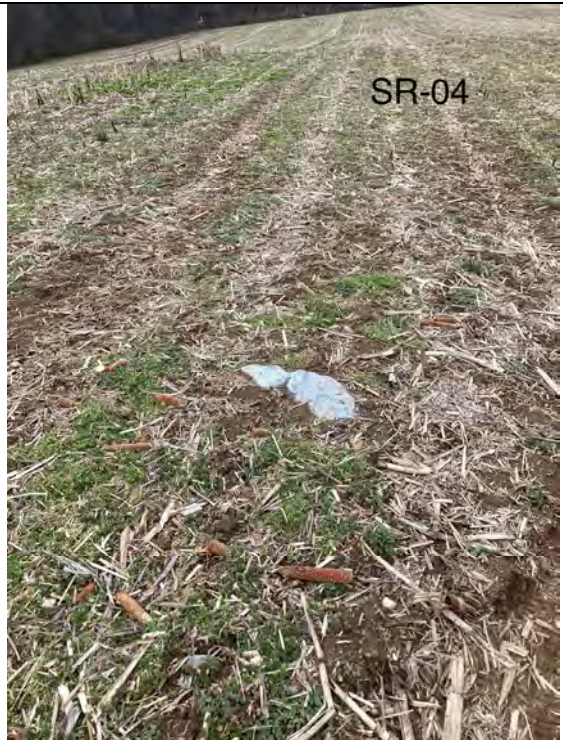
SR-04

Surficial Rock (SR-04)

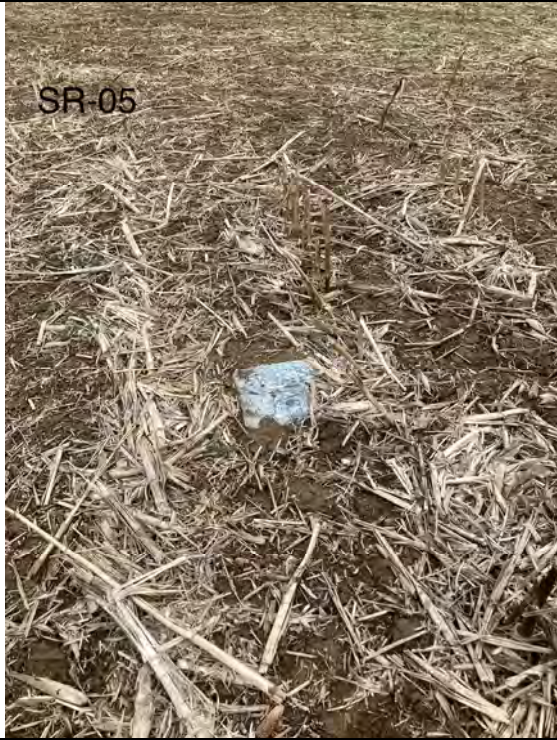
Surficial Rock (SR-05)

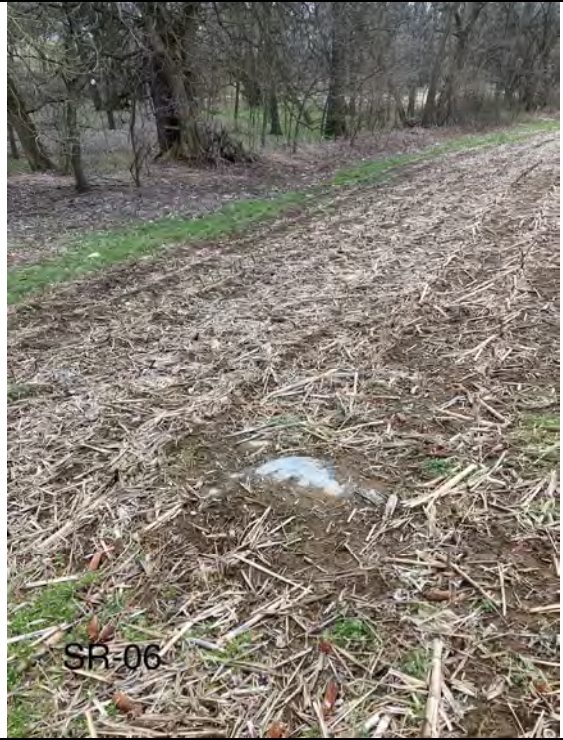
Surficial Rock (SR-06)

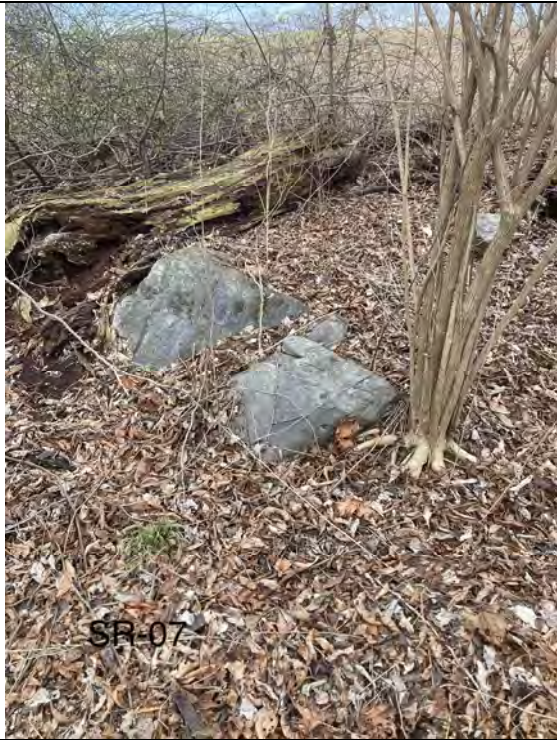
Surficial Rock (SR-07)

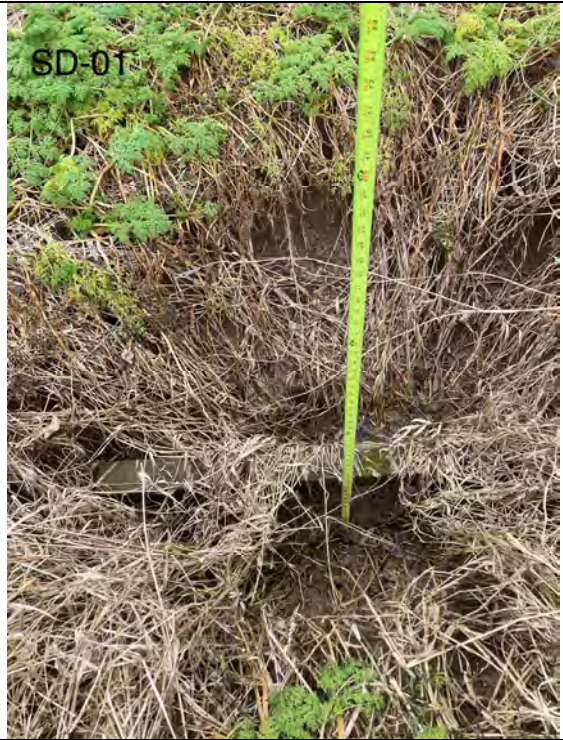
potential sinkhole/subsidence feature, surficial rock, and a surficial depression were observed. The locations of these features are presented in the table below.

Sinkhole/Subsidence Feature

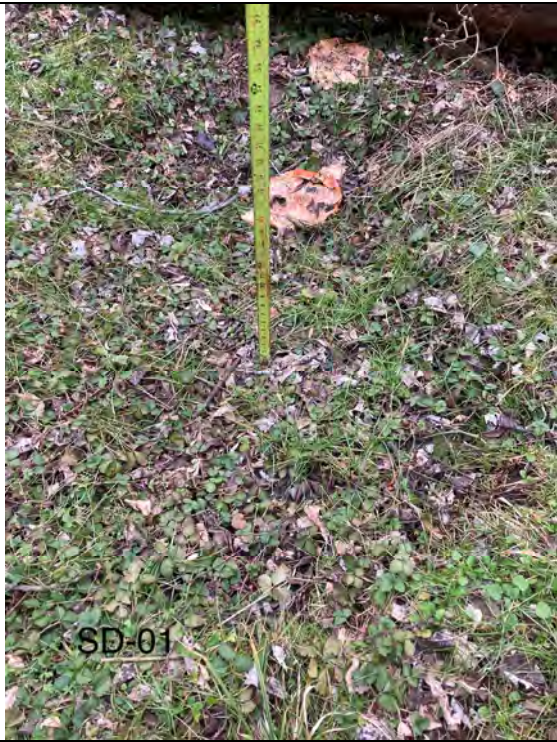
Surface Depression (SD-01)

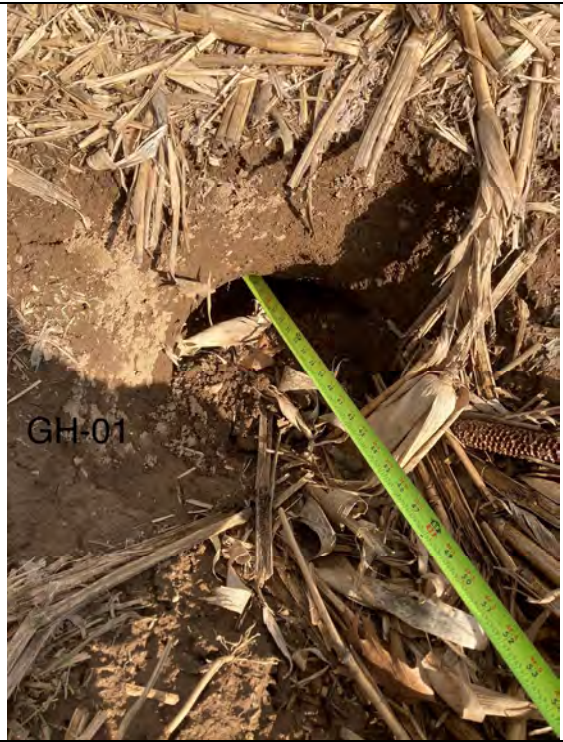
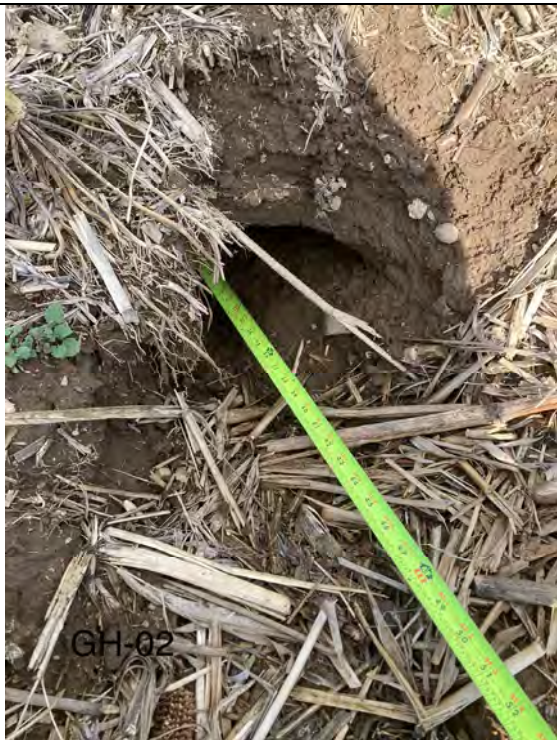
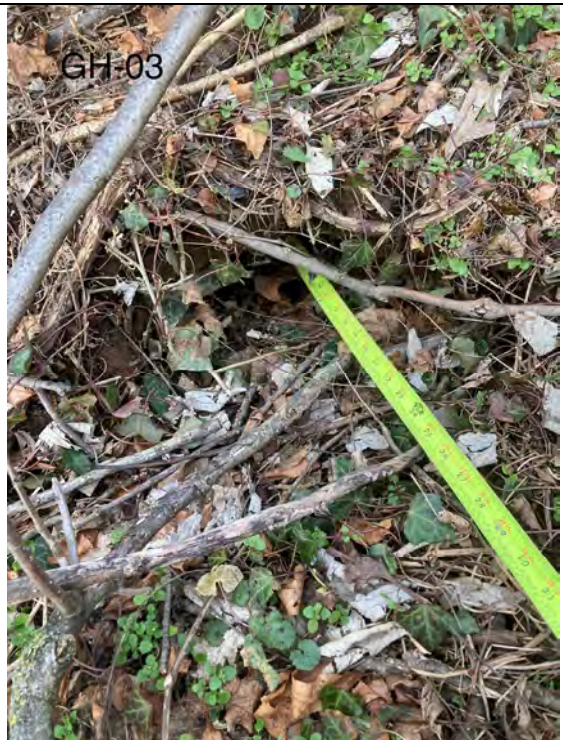
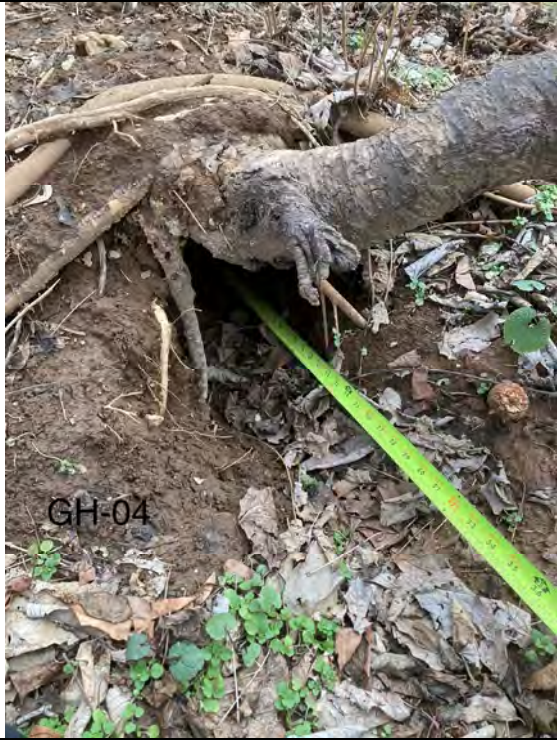
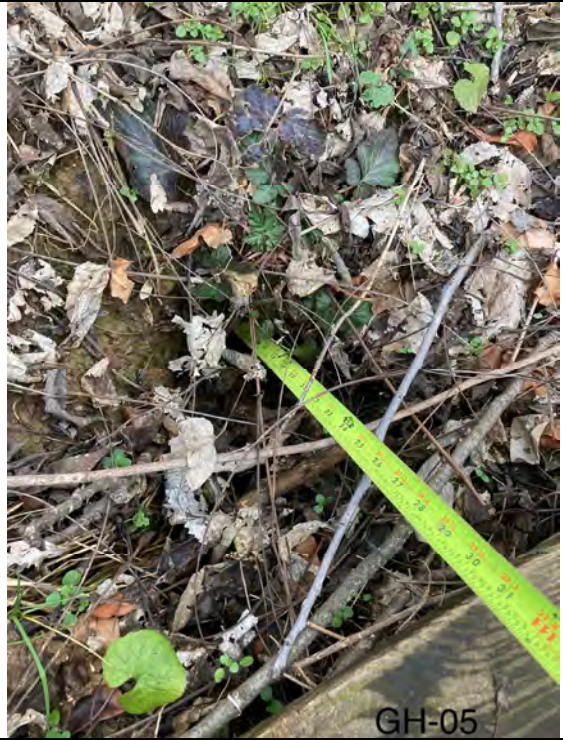
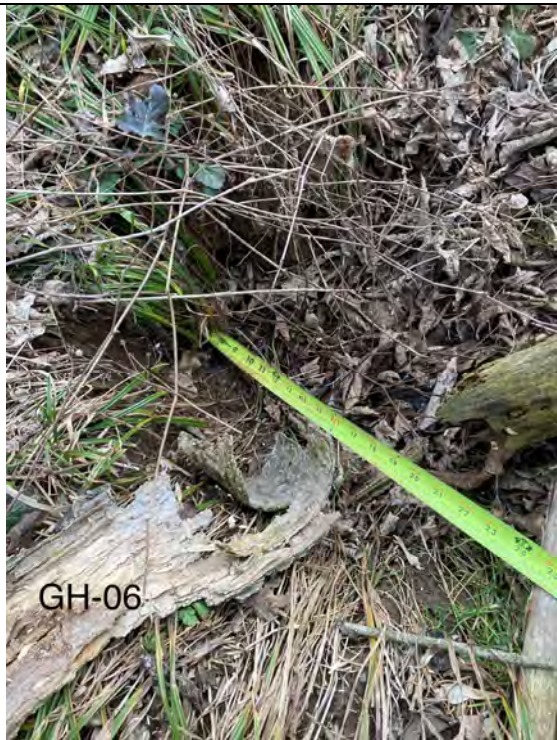
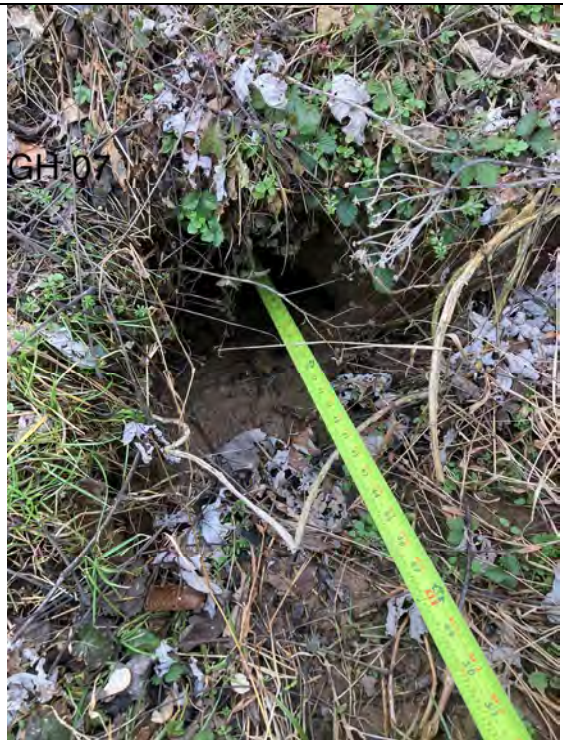
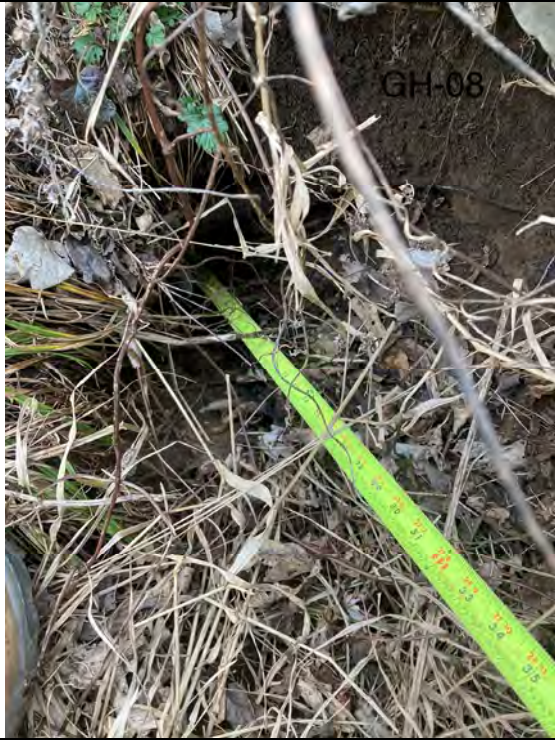
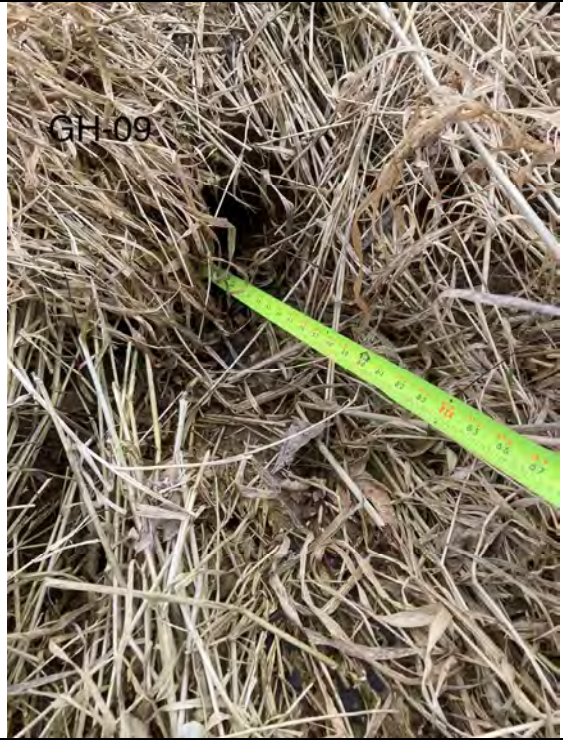
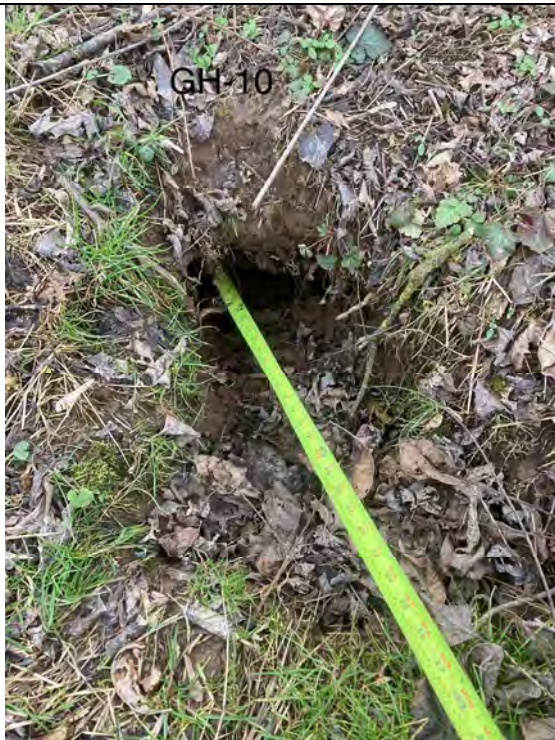
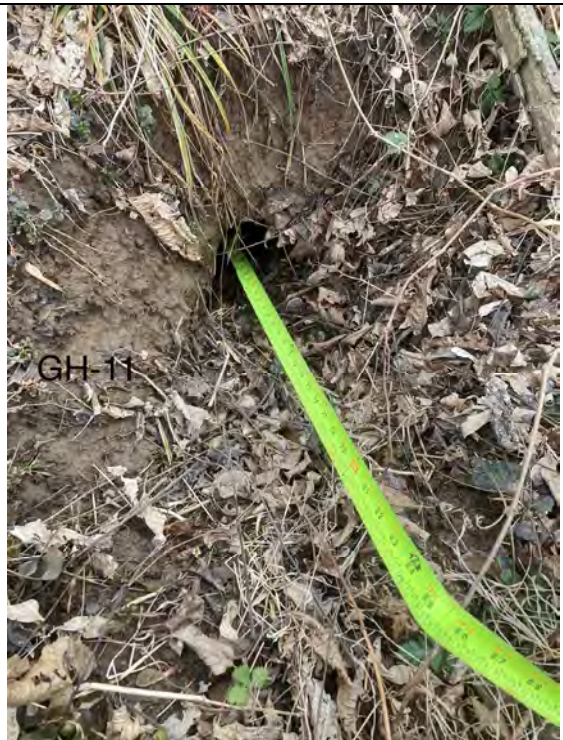
Additionally, apparent animal burrows were frequently observed during the site walk generally located around the eastern portion of the site, which can potentially be indicative of soft/loose soils associated with karst activity.

Animal Burrow (GH-01)

Animal Burrow (GH-02)

Animal Burrow (GH-03)

Animal Burrow (GH-04)

Animal Burrow (GH-05)

Animal Burrow (GH-06)

Animal Burrow (GH-07)

Animal Burrow (GH-08)

Animal Burrow (GH-09)

Animal Burrow (GH-10)

Animal Burrow (GH-11)
