Geotechnical Engineering Report for Stormwater Management

Greiner Warehouse

2861 Mount Pleasant Road
Mount Joy Township, Lancaster County, Pennsylvania

ECS Project Number 18:5665

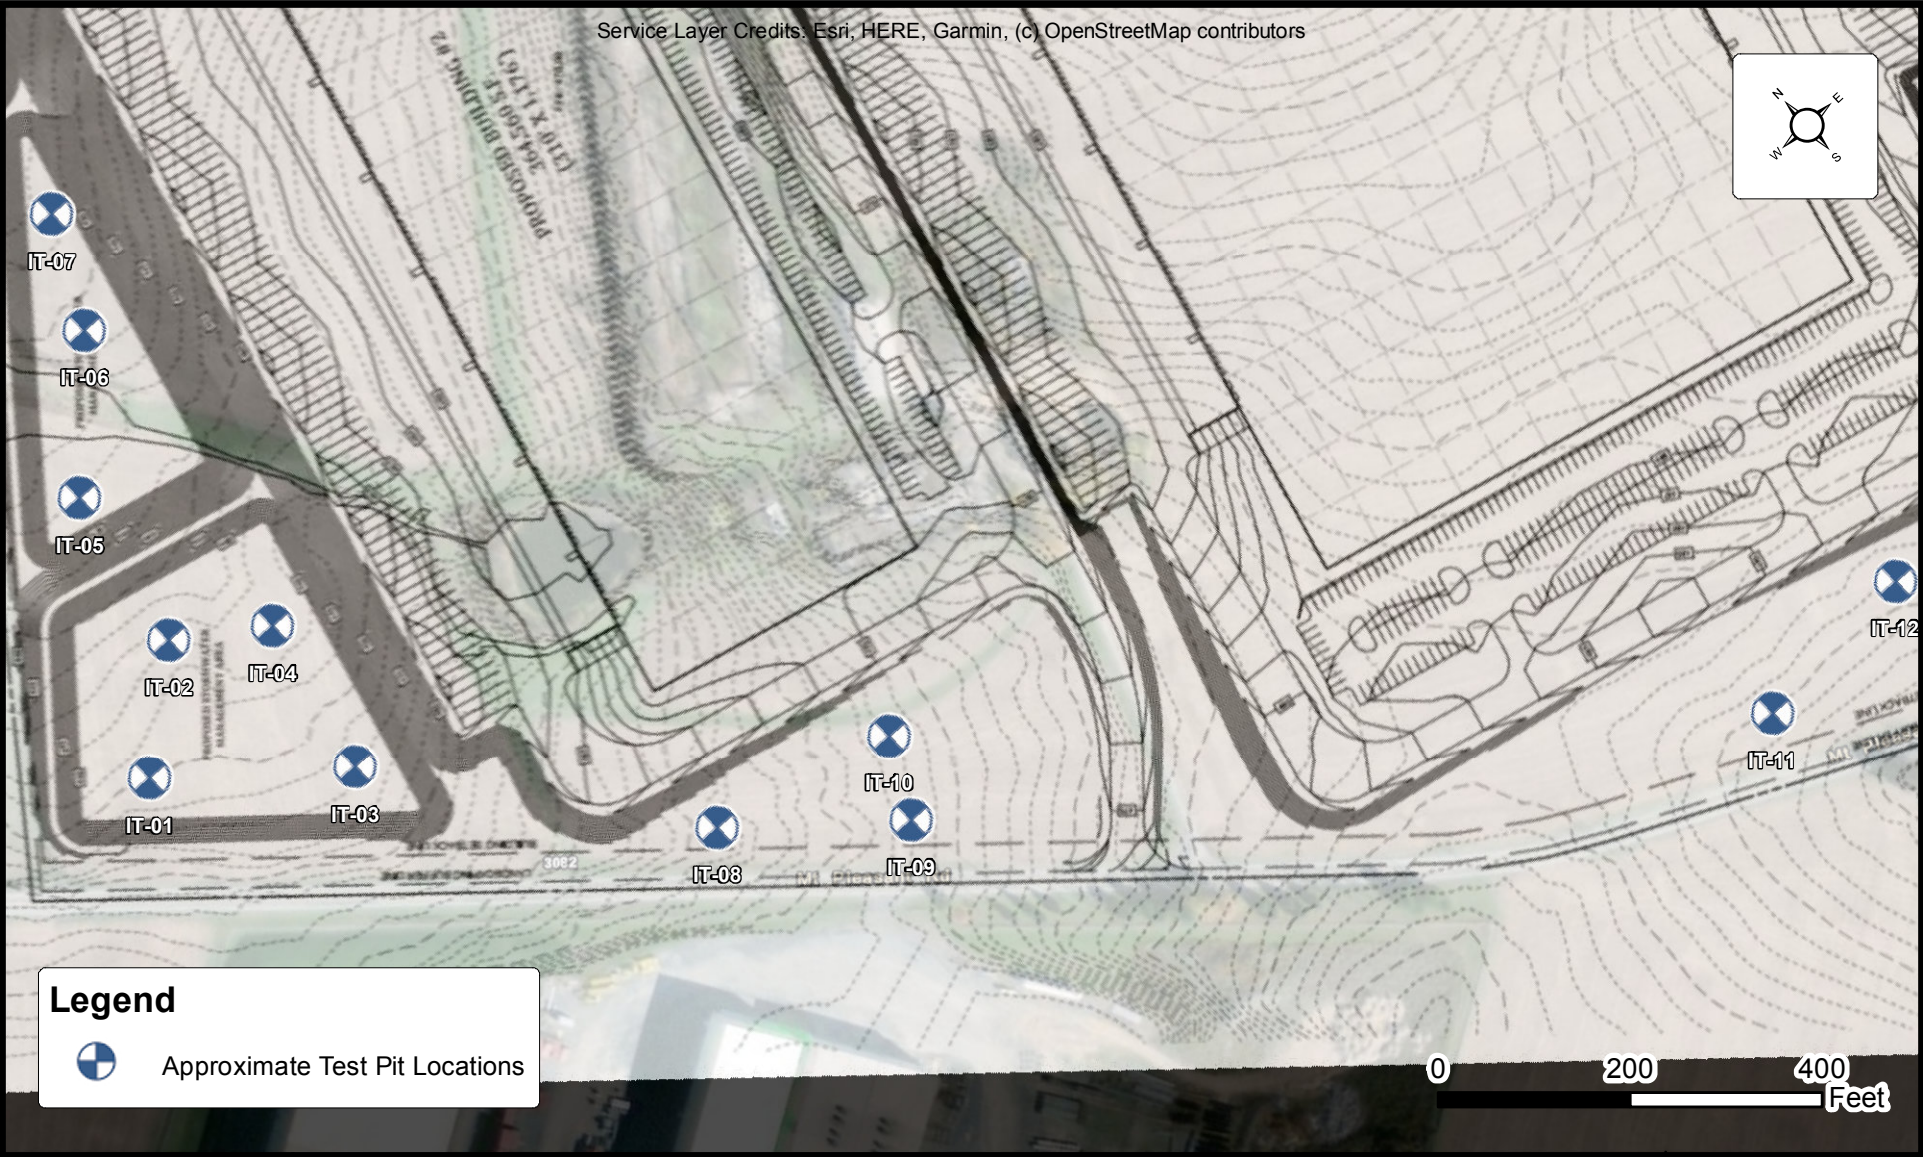
Our scope of work included excavating twelve (12) test pits and performing corresponding infiltration tests in each. Our test pits were located with a handheld GPS unit and their approximate locations are shown on the Exploration Location Plan in Appendix A.

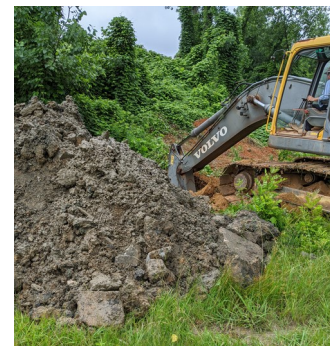
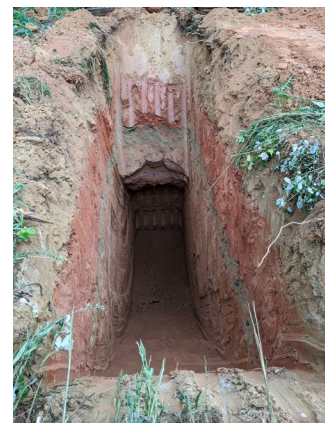
TEST PIT Procedure:

- Involves excavation subsurface material to observe composition and physical characteristics
- Recording the approximate depth of subsurface strata
- Excavation is continued as prescribed or to limits of equipment and subsurface conditions
- The exploration is typically carried out with an excavator or backhoe, with the depth dependent on machine size and ground

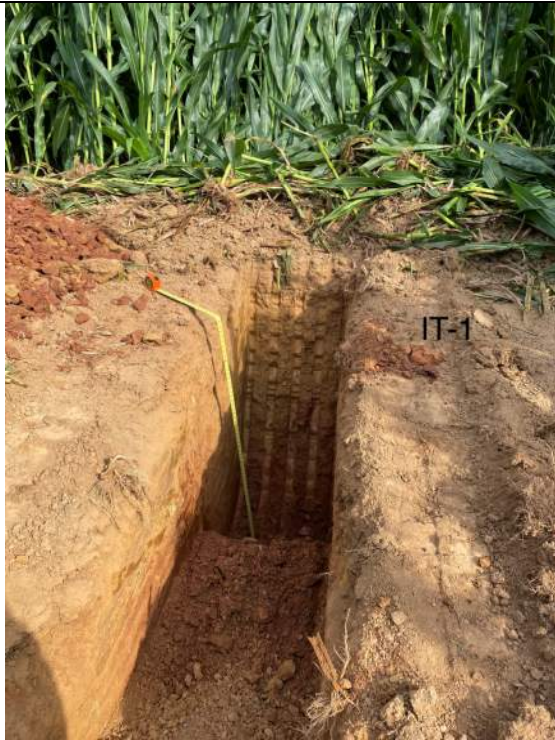
Test Pit IT-01

DEPTH (FT)	WATER LEVELS	ELEVATION (FT)	DESCRIPTION OF MATERIAL	EXCAVATION EFFORT	DCP	QP (TSF)	SAMPLE NUMBER	MOISTURE CONTENT (%)
5		440	Topsoil Thickness[12.00"]	E		4.00	S-1	
			(ML) SILT WITH GRAVEL, reddish brown, moist, hard, 2.5YR 4/8	M				
			(GP-GM) GRAVEL WITH SILT, reddish brown, moist, 2.5YR 4/8, Potential Fragipan Encountered at 1'-5'	D				
			END OF TEST PIT AT 7.5 FT					
10		435						
15		430

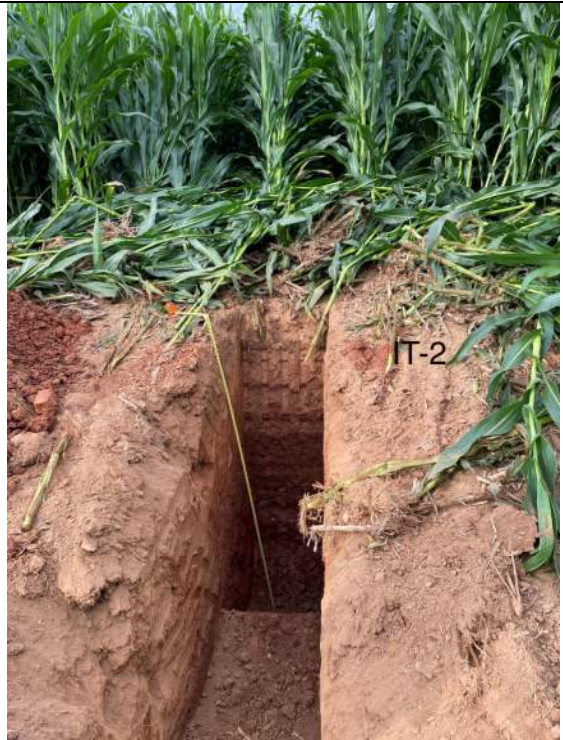
Test Pit IT-02

DEPTH (FT)	WATER LEVELS	ELEVATION (FT)	DESCRIPTION OF MATERIAL	EXCAVATION EFFORT	DCP	QP (TSF)	SAMPLE NUMBER	MOISTURE CONTENT (%)
			Topsoil Thickness[12.00"]	E				
			(SC) Clayey SAND with Gravel, light brown, moist, very dense, 2.5YR 7/6, Potential Fragipan Encountered at 1'-4.5'	D		4.50	S-1	11.8
5		438	END OF TEST PIT AT 4.5 FT					
10		433						
15		428

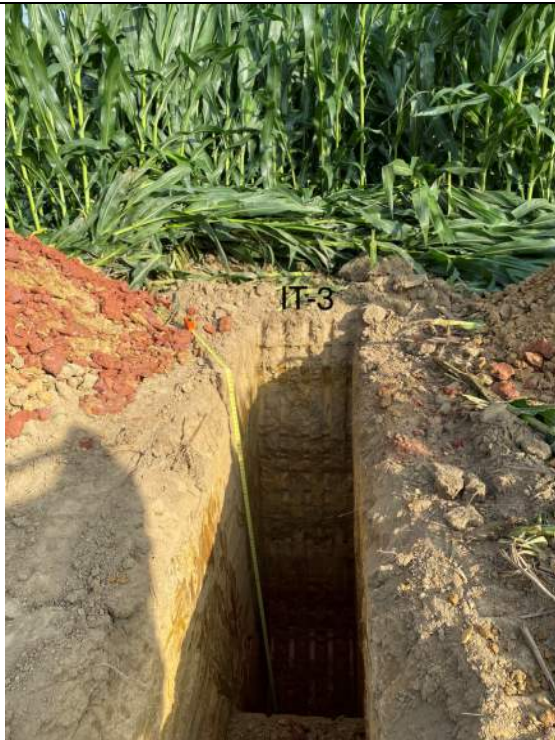
Test Pit IT-03

DEPTH (FT)	WATER LEVELS	ELEVATION (FT)	DESCRIPTION OF MATERIAL	EXCAVATION EFFORT	DCP	QP (TSF)	SAMPLE NUMBER	MOISTURE CONTENT (%)
			Topsoil Thickness[12.00"]	E				
			(ML) SILT, light brown, moist, hard, 2.5YR 7/6	M		4.50		
5		442	(ML) SILT WITH GRAVEL, reddish brown, moist, hard, 2.5YR 4/8, Potential Fragipan Encountered at 1'-6'	D		3.50	S-1	
			END OF TEST PIT AT 8.5 FT					
10		437						
15		432

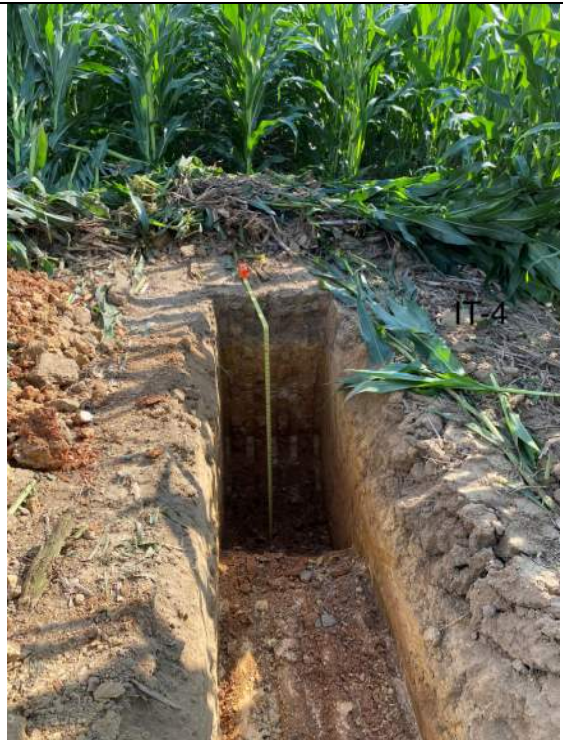
Test Pit IT-04

DEPTH (FT)	WATER LEVELS	ELEVATION (FT)	DESCRIPTION OF MATERIAL	EXCAVATION EFFORT	DCP	QP (TSF)	SAMPLE NUMBER	MOISTURE CONTENT (%)
			Topsoil Thickness[12.00"]	E				
			(ML) SILT WITH GRAVEL, light brown, moist, hard, 2.5YR 7/6, Potential Fragipan Encountered at 1' to EOP	M		4.50	S-1	
			END OF TEST PIT AT 4.0 FT					
5		437						
10		432						
15

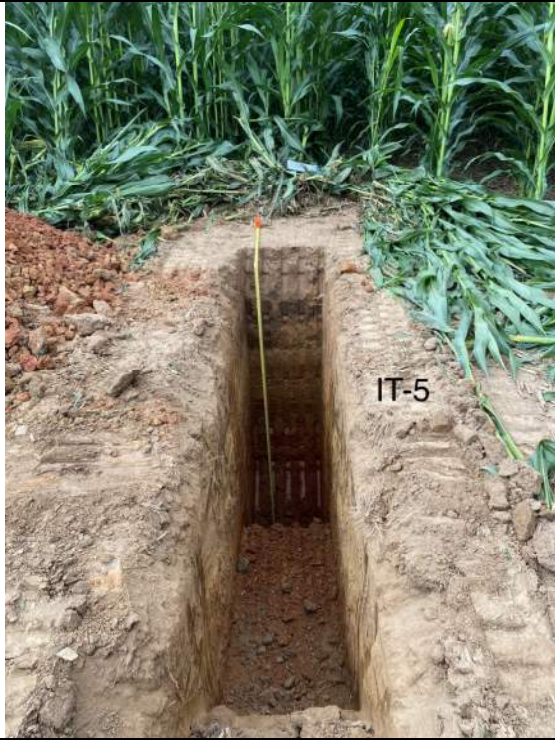
Test Pit IT-05

DEPTH (FT)	WATER LEVELS	ELEVATION (FT)	DESCRIPTION OF MATERIAL	EXCAVATION EFFORT	DCP	QP (TSF)	SAMPLE NUMBER	MOISTURE CONTENT (%)
5		433	Topsoil Thickness[12.00"]	E		4.00	S-1	
			(ML) SILT, light brown to reddish brown, moist, hard, 2.5YR 7/6, 2.5YR 4/8, Potential Fragipan Encountered at 1'-EOP	M				
10		428	END OF TEST PIT AT 8.0 FT					
15

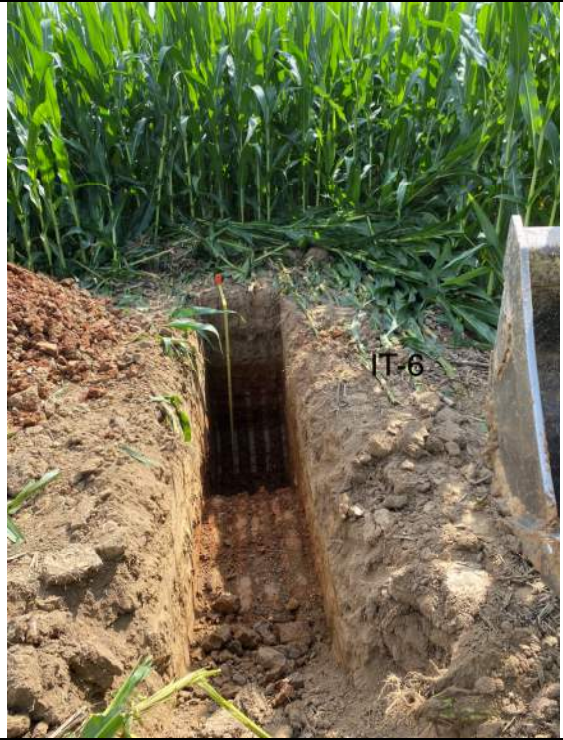
Test Pit IT-06

DEPTH (FT)	WATER LEVELS	ELEVATION (FT)	DESCRIPTION OF MATERIAL	EXCAVATION EFFORT	DCP	QP (TSF)	SAMPLE NUMBER	MOISTURE CONTENT (%)
5		431	Topsoil Thickness[12.00"]	E		3.50	S-1	
			(ML) GRAVELLY SILT, reddish brown, moist, very stiff, 2.5YR 4/8, Potential Fragipan Encountered at 1'-5.5'	M				
			END OF TEST PIT AT 5.5 FT					
10		426						
15		421

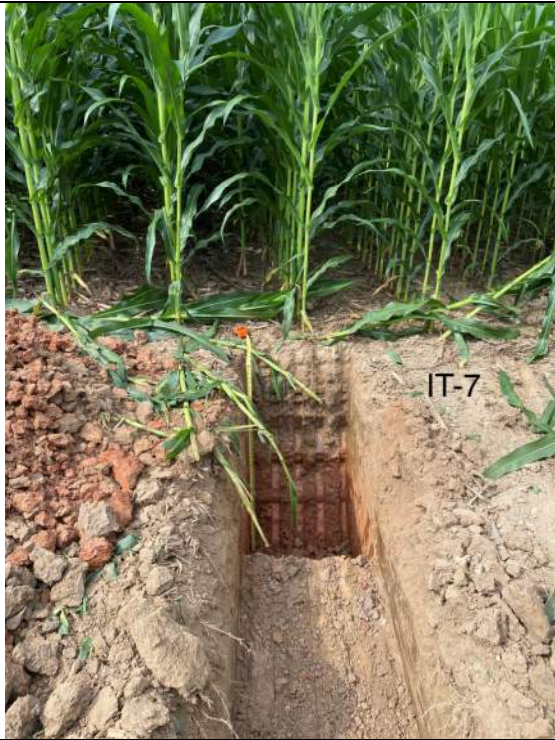
Test Pit IT-07

DEPTH (FT)	WATER LEVELS	ELEVATION (FT)	DESCRIPTION OF MATERIAL	EXCAVATION EFFORT	DCP	QP (TSF)	SAMPLE NUMBER	MOISTURE CONTENT (%)
			Topsoil Thickness[12.00"]	E				
			(ML) SILT, light brown, moist, hard, 2.5YR 7/6, Potential Fragipan Encountered at 1'-4'	M		4.00	S-1	
			END OF TEST PIT AT 4.0 FT					
5		429						
10		424						
15		419

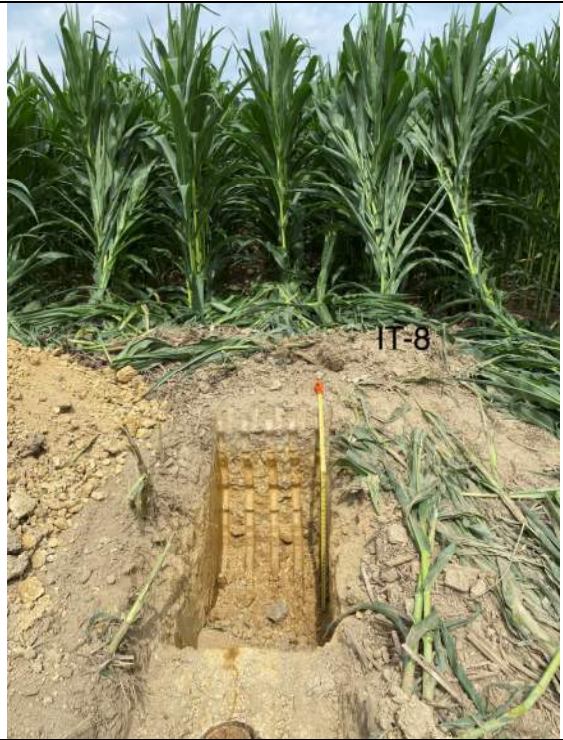
Test Pit IT-08

DEPTH (FT)	WATER LEVELS	ELEVATION (FT)	DESCRIPTION OF MATERIAL	EXCAVATION EFFORT	DCP	QP (TSF)	SAMPLE NUMBER	MOISTURE CONTENT (%)
			Topsoil Thickness[12.00"]	E		4.50	S-1	
			(ML) SILT WITH GRAVEL, light brown, moist, hard, 2.5YR 7/6, Potential Fragipan Encountered at 1'-3'	M				
			END OF TEST PIT AT 3.0 FT					
5		455						
10		450						
15

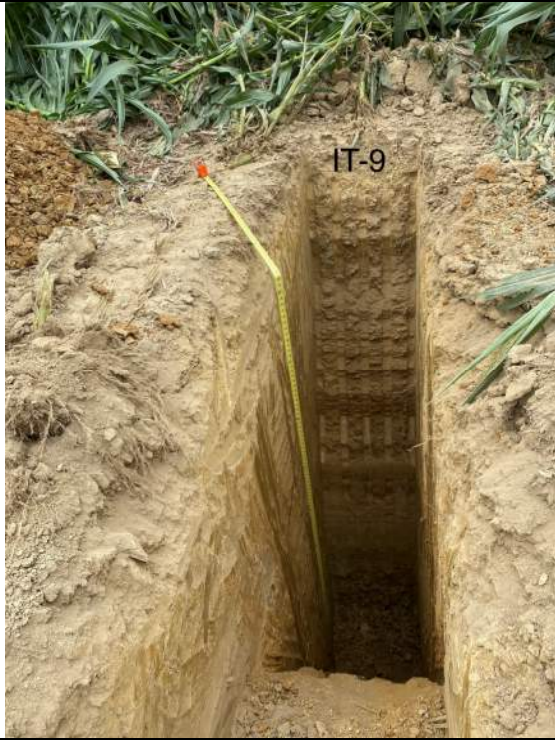
Test Pit IT-09

DEPTH (FT)	WATER LEVELS	ELEVATION (FT)	DESCRIPTION OF MATERIAL	EXCAVATION EFFORT	DCP	QP (TSF)	SAMPLE NUMBER	MOISTURE CONTENT (%)
5		463	Topsoil Thickness[12.00"]	E		4.00		
			(ML) SILT WITH GRAVEL, light brown, moist, hard, 2.5YR 7/6	M				
			(ML) GRAVELLY SILT, orangish brown, moist, hard, 2.5YR 6/8, Potential Fragipan Encountered at 1'-5'	D				
10		458	END OF TEST PIT AT 10 FT			4.50	S-1	
15		453

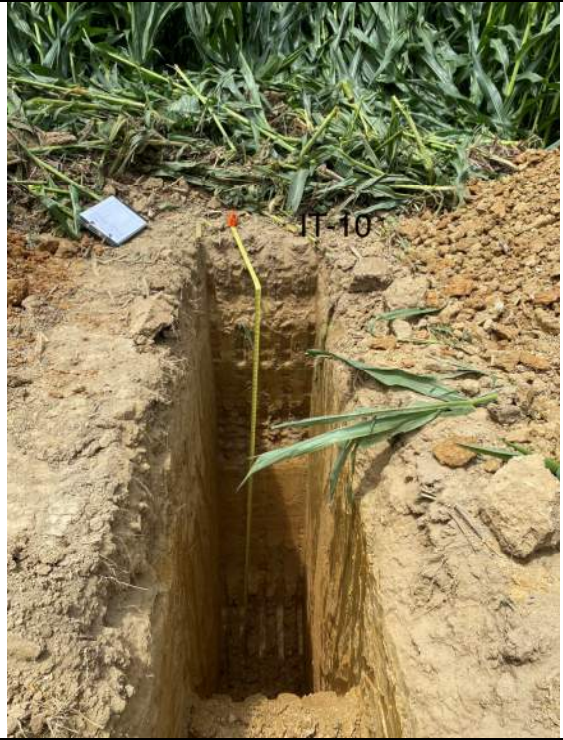
Test Pit IT-10

DEPTH (FT)	WATER LEVELS	ELEVATION (FT)	DESCRIPTION OF MATERIAL	EXCAVATION EFFORT	DCP	QP (TSF)	SAMPLE NUMBER	MOISTURE CONTENT (%)
			Topsoil Thickness[12.00"]	E				
			(ML) SILT WITH GRAVEL, light brown, moist, 2.5YR 7/6	M				
5		463	(ML) GRAVELLY SILT, orangish brown, moist, 2.5YR 6/8, Potential Fragipan Encountered at 1'-5'	D		4.00	S-1	
10		458	END OF TEST PIT AT 10.0 FT					
15		453

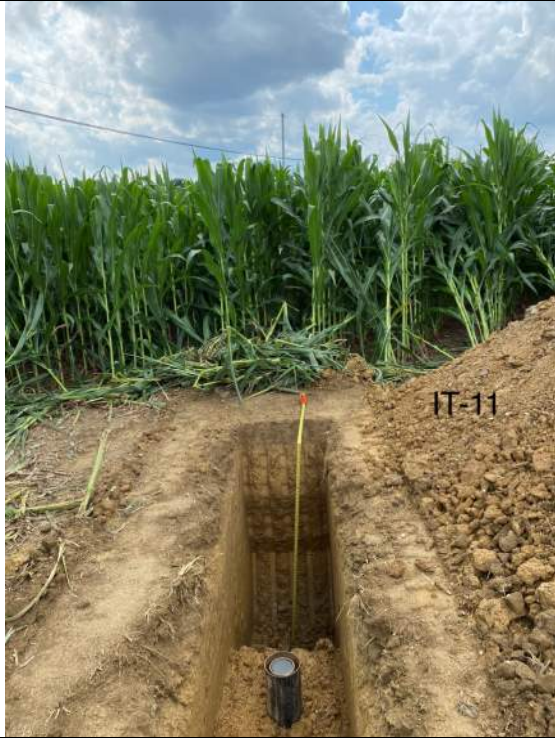
Test Pit IT-11

DEPTH (FT)	WATER LEVELS	ELEVATION (FT)	DESCRIPTION OF MATERIAL	EXCAVATION EFFORT	DCP	QP (TSF)	SAMPLE NUMBER	MOISTURE CONTENT (%)
5		475	Topsoil Thickness[12.00"]	E		4.00	S-1	
			(ML) SILT, light brown, moist, hard, 2.5YR 7/6, Potential Fragipan Encountered at 1'-5'	M				
			END OF TEST PIT AT 5.0 FT					
10		470						
15		465

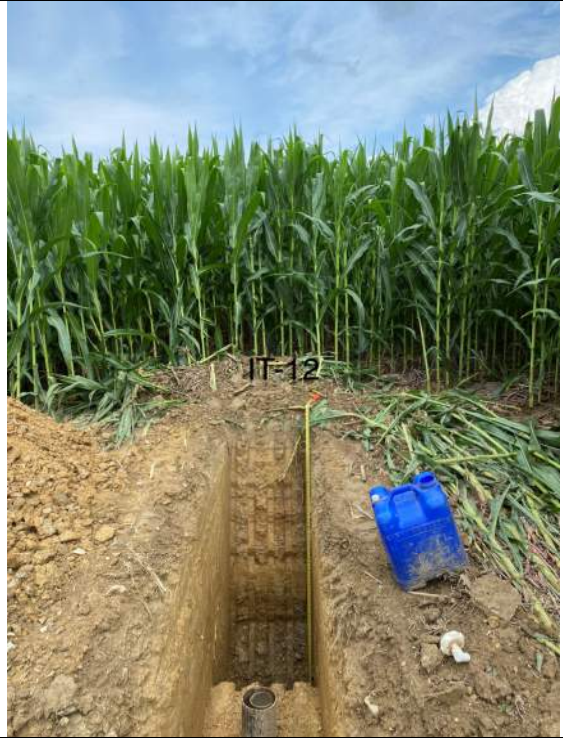
Test Pit IT-12

DEPTH (FT)	WATER LEVELS	ELEVATION (FT)	DESCRIPTION OF MATERIAL	EXCAVATION EFFORT	DCP	QP (TSF)	SAMPLE NUMBER	MOISTURE CONTENT (%)
5		476	Topsoil Thickness[12.00"]	E		4.00	S-1	18.9
			(ML) Sandy SILT, light brown, moist, hard, 2.5YR 7/6, Potential Fragipan Encountered at 1'-6'	E				
			END OF TEST PIT AT 6.0 FT					
10		471						
15		466

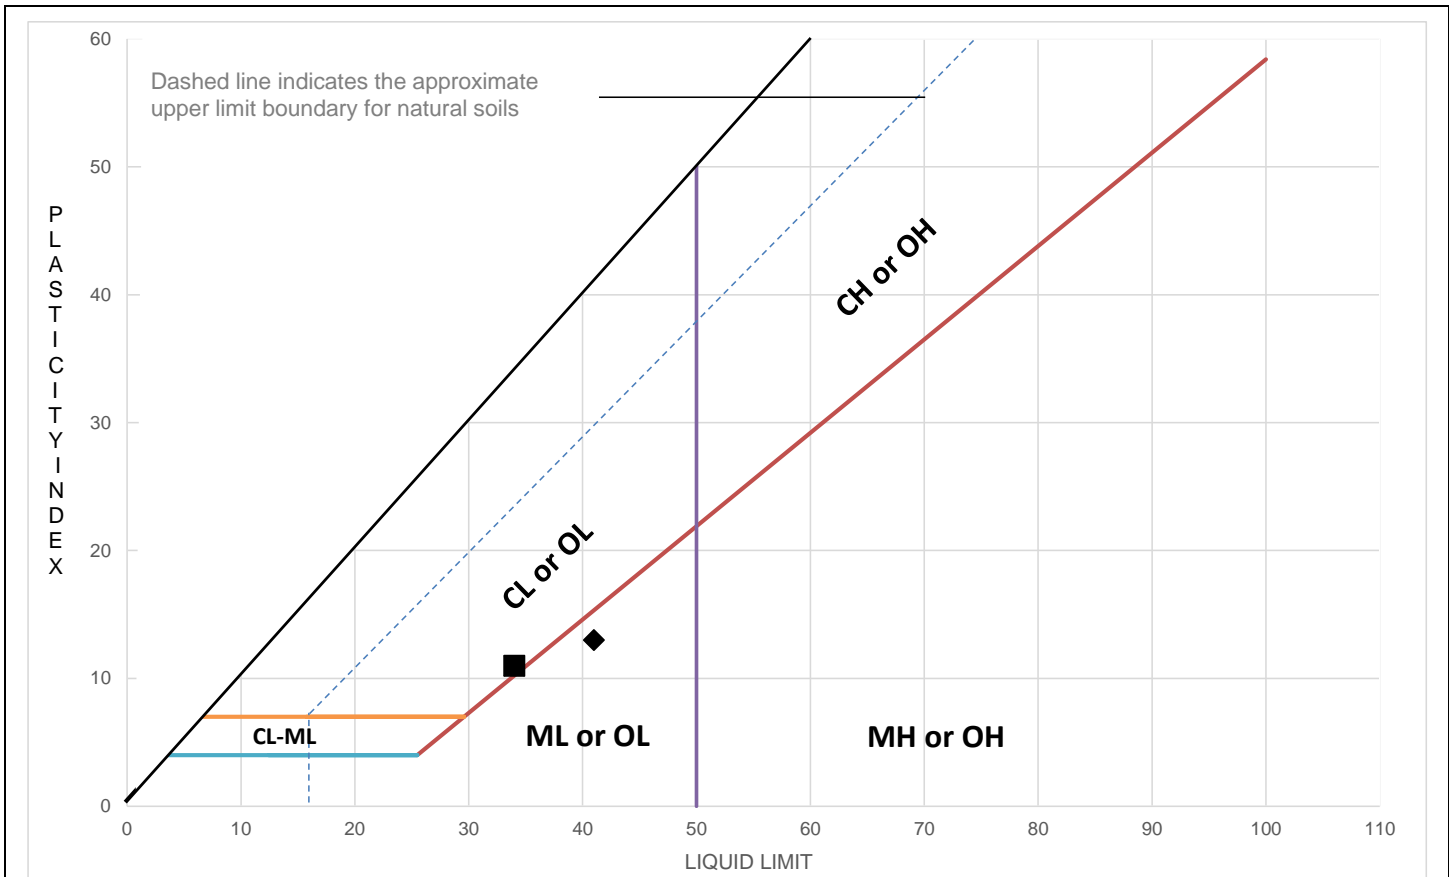
LIQUID AND PLASTIC LIMITS TEST REPORT

TEST RESULTS (ASTM D4318-10 (MULTIPOINT TEST))

Symbol	Sample Location	Sample Number	Sample Depth (ft)	LL	PL	PI	%<#40	%<#200	AASHTO	USCS	Material Description
■	IT-02	S-1	2.5	34	23	11	58.4	46.7	A-6	SC	Clayey Sand with Gravel
◆	IT-12	S-1	3.5	41	28	13	68.6	62.8	A-7-6	ML	Sandy Silt

Sample Location	Sample Number	Depth (feet)	^MC (%)	Soil Type	Atterberg Limits			**Percent Passing No. 200 Sieve	Moisture - Density		CBR (%)		#Organic Content (%)
					LL	PL	PI		<Maximum Density (pcf)	<Optimum Moisture (%)	0.1 in.	0.2 in.	
IT-02	S-1	2.5	11.8	SC	34	23	11	46.7					
IT-12	S-1	3.5	18.9	ML	41	28	13	62.8

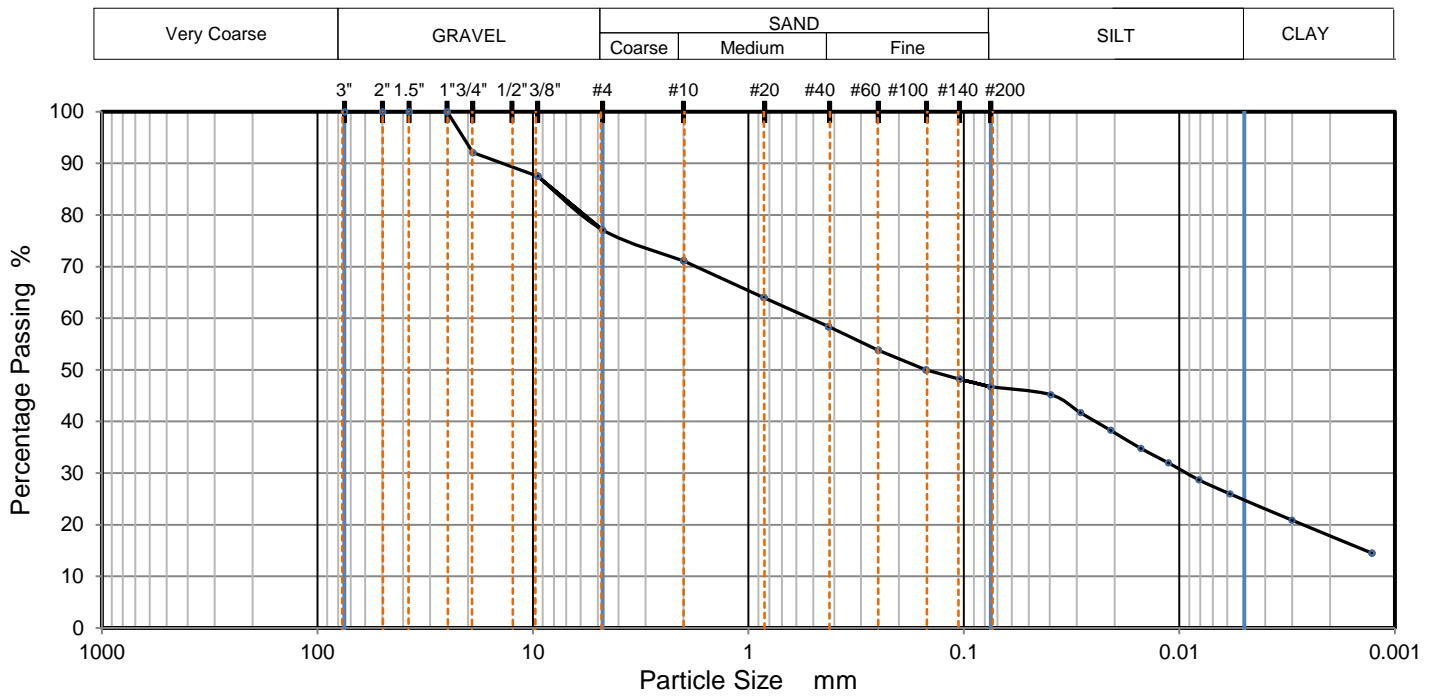
PARTICLE SIZE DISTRIBUTION

TEST RESULTS (ASTM D6913M-17-METHOD A)

Sieving		Hydrometer Sedimentation	
Particle Size	% Passing	Particle Size mm	% Passing
3"	100	0.0396	45
2"	100	0.0288	42
1 1/2"	100	0.0209	38
1"	100	0.0151	35
3/4"	92	0.0113	32
3/8"	88	0.0081	29
#4	77	0.0058	26
#10	71	0.0030	21
#20	64	0.0013	15
#40	58		
#60	54		
#100	50		
#140	48		
#200	47		
		Specific Gravity (Historical) 2.65

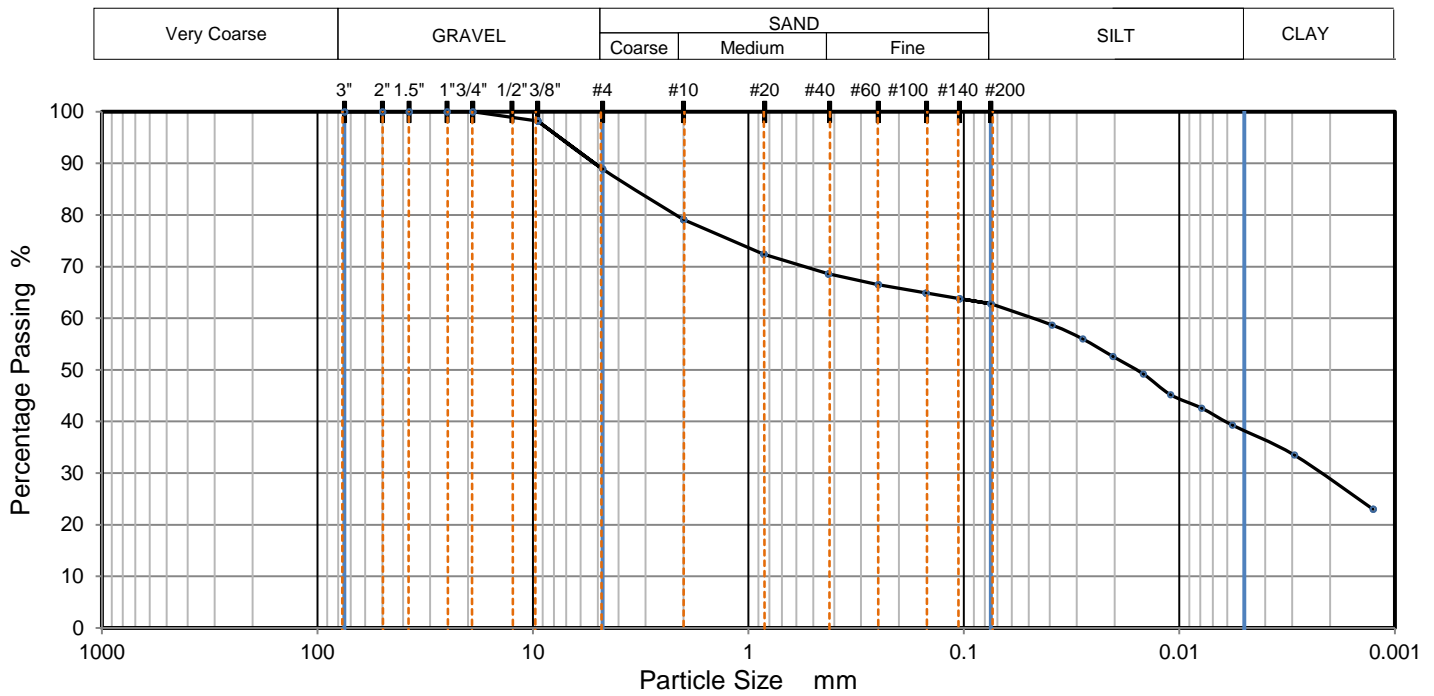
PARTICLE SIZE DISTRIBUTION

TEST RESULTS (ASTM D6913M-17-METHOD A)

Sieving		Hydrometer Sedimentation	
Particle Size	% Passing	Particle Size mm	% Passing
3"	100	0.0391	59
2"	100	0.0282	56
1 1/2"	100	0.0204	53
1"	100	0.0147	49
3/4"	100	0.0110	45
3/8"	98	0.0079	43
#4	89	0.0057	39
#10	79	0.0029	34
#20	72	0.0013	23
#40	69		
#60	67		
#100	65		
#140	64		
#200	63		
		Specific Gravity (Historical) 2.65

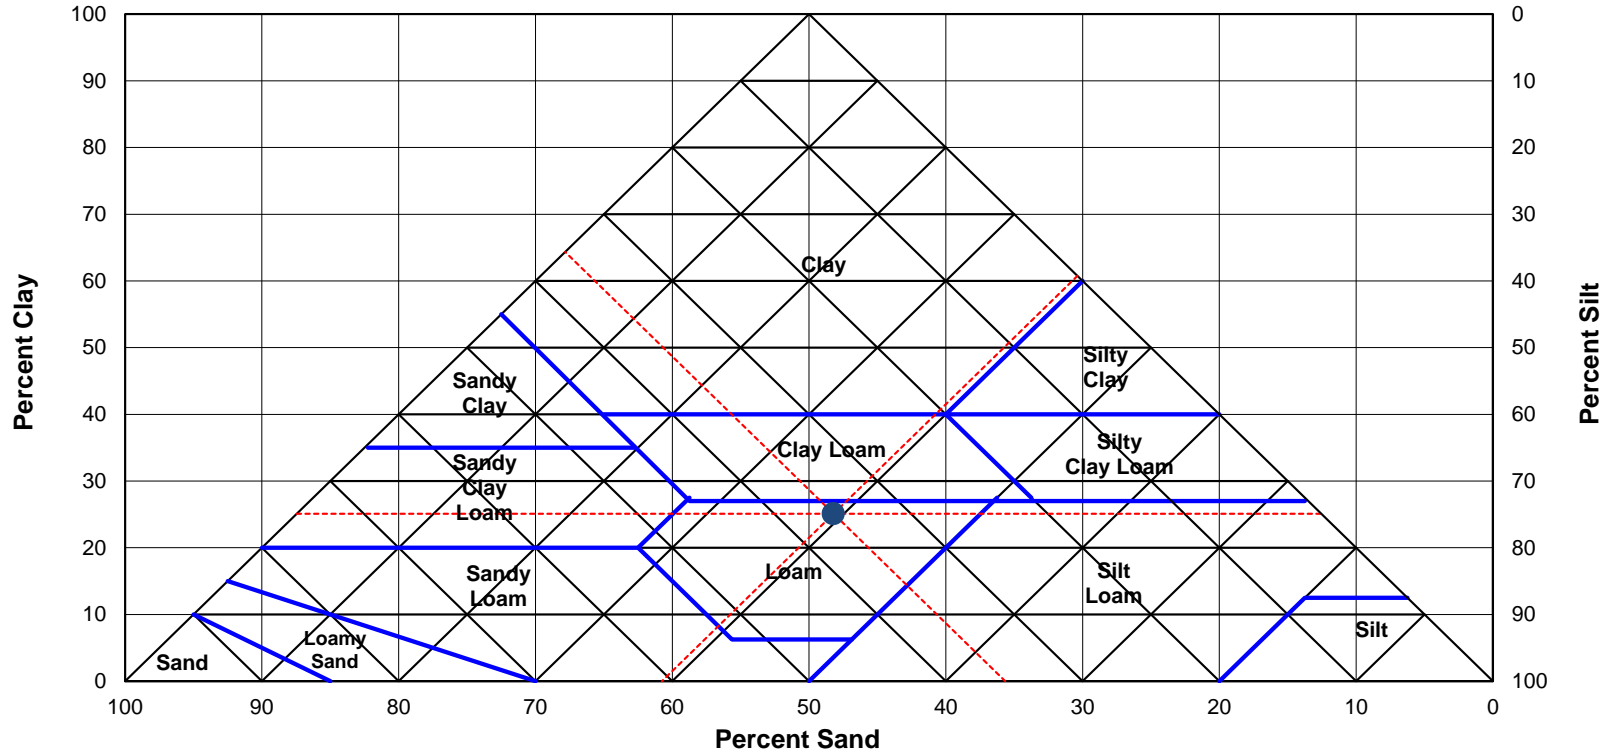
Textural Triangle USDA

%Sand	%Silt	%Clay
35.7	39.2	25.1

Project: Greiner Warehouse
 Client: Landworks Civil Design, LLC
 Sample Description: Clayey Sand with Gravel
 Sample Source: IT-02

Project No.: 18:5665
 Depth (ft): 2.5
 Sample No.: S-1
 Date Reported: 8/16/2022

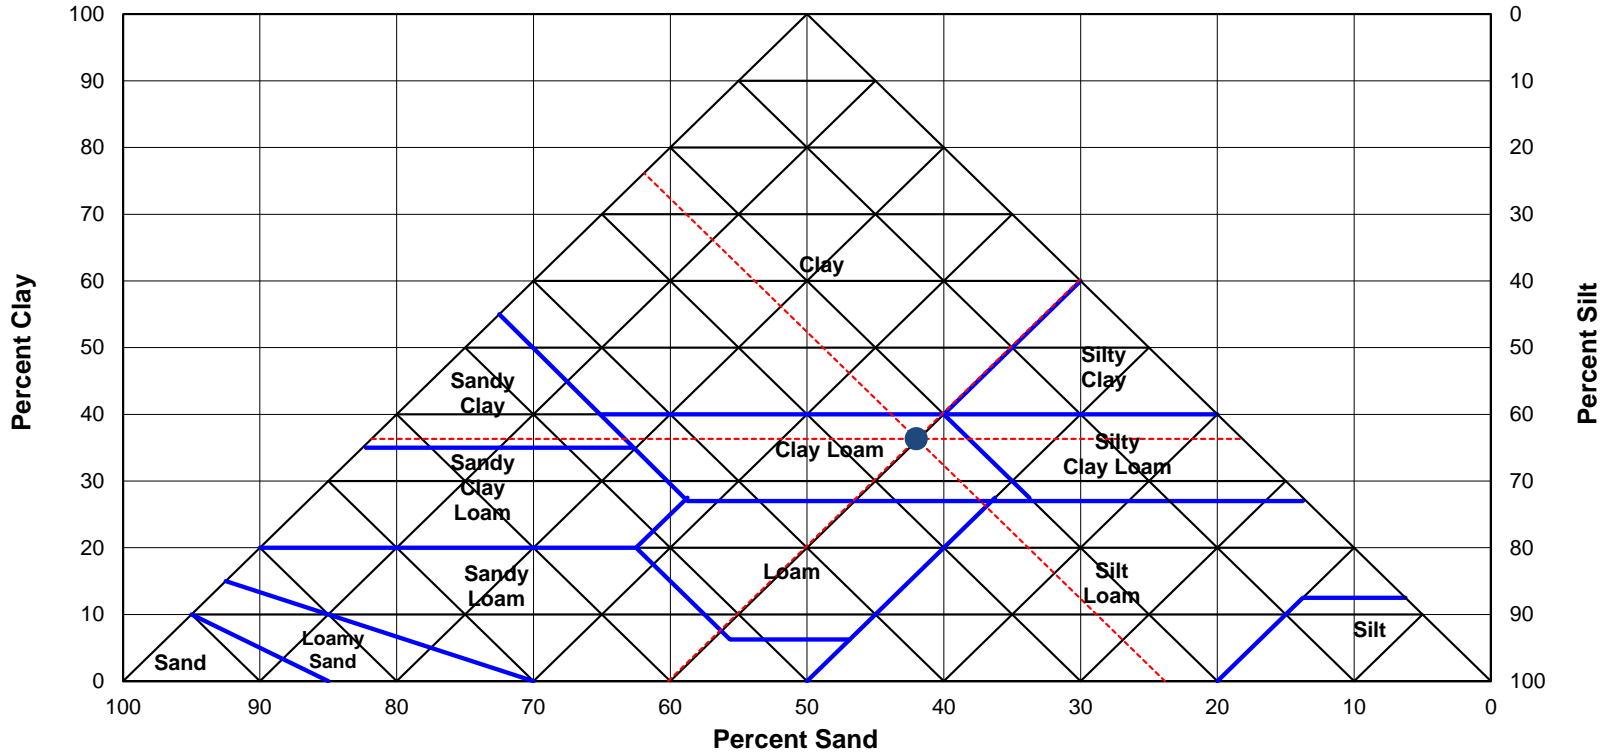
Textural Triangle USDA

%Sand	%Silt	%Clay
23.8	39.8	36.3

Project: Greiner Warehouse
 Client: Landworks Civil Design, LLC
 Sample Description: Sandy Silt
 Sample Source: IT-12

Project No.: 18:5665
 Depth (ft): 3.5
 Sample No.: S-1
 Date Reported: 8/16/2022
